## **W.K. DWYER SCHOOL BUILDING** **STRUCTURAL SYSTEM EVALUATION**

The W.K. Dwyer School Building is located on the West side of Anaconda, MT at 1601 Tammany St. The school served the community of Anaconda from completion of construction in the late 1950's to the mid 2010's when School Board budget constraints necessitated its closure. With the school currently vacant, a desire to transform the building into a community center has arisen. In support of this desire, Hicks Engineering has been hired to provide documentation of structural systems present, a conditional assessment of those systems, and any foreseeable modifications to these systems required to transform the building into a safe and serviceable community center.

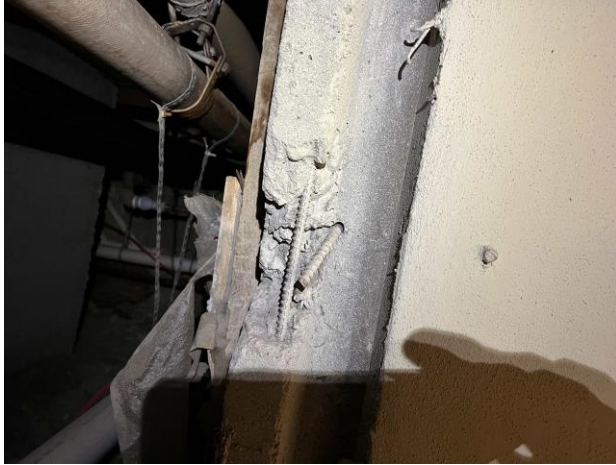
Small spread footings could be seen protruding beyond the wall's base at masonry pilaster locations (above). Their width was measured as 28" (parallel to the wall), but given the one-sided access to the foundation wall, their overall dimensions could not be measured. Also coming off the bottom of the foundation walls were 12" wide grade beams that spanned the base of the utility tunnel, located between each pilaster footing location. These grade beams were spaced at roughly 15'-0" o.c. along the length of the tunnel and presumed to be bracing the bottom edges of the tunnel's interior and exterior walls from sliding inward due to lateral earth pressure. Capping the tunnel and bracing the top of the walls was a +/- 6 1/2" thick concrete slab on non-composite metal deck.

Item S1 – Typical Main Level Classroom Foundation wall. Reinforcing steel protruding from wall.

**Recommendations:** When considering the repurposing of this structure, the design team should understand that the existing exterior foundations will likely require additional support. Post-installed helical piers with retrofit connections to the foundation walls / grade beams would be a minimally intrusive option when deployed at targeted discrete points around the exterior foundations. It is also recommended that the design team develop a plan to provide improved insulation and damp proofing to utility tunnel that wraps the building perimeter.

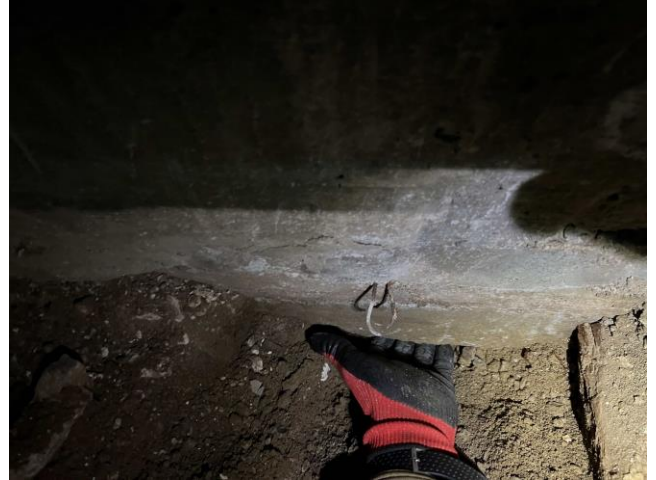
**Condition:** Given their age, the exterior concrete foundation elements observed (walls, footings, and perpendicular grade beams) appeared to be in sound condition. The elements observed did not show signs of significant structural cracking, spalling, or other degradation that would indicate a loss in structural load-carrying capabilities. Despite the elements being in good condition, it is likely that due of the lack of a significant footing system below the foundations walls, the foundation system will produce excessive bearing pressures on the sub grade below relative to acceptable soil bearing capacity if analyzed under current building code requirements.

Item S1 – Typical Main Level Foundation wall base. No continuous wall footing present.

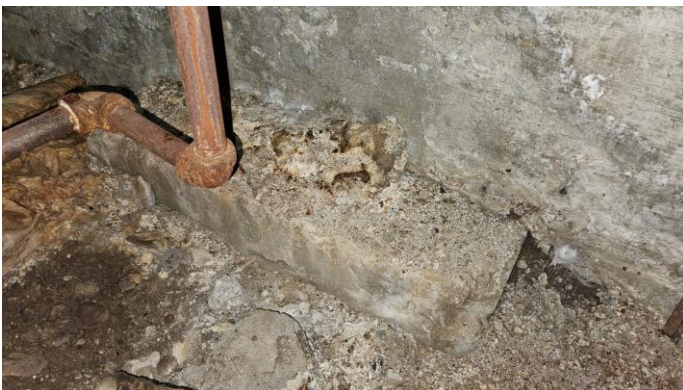
Item S1 – Typical spread footing below masonry pilaster at Main Level Classrooms.

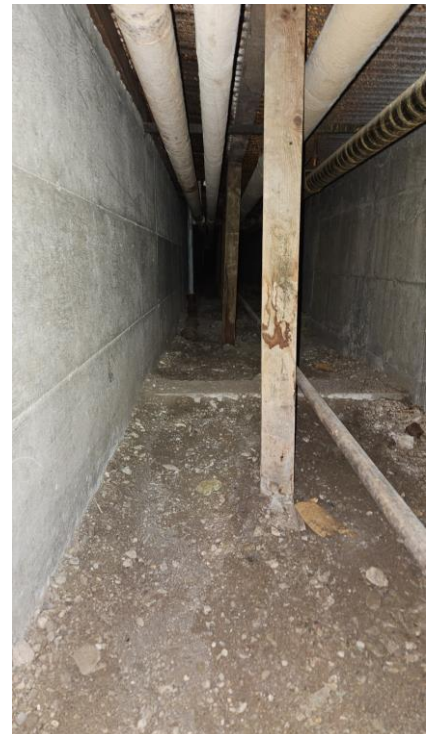
Item S1 – Typical utility tunnel around exterior of Main Level Classroom space. Grade beam tie between foundation walls beyond.

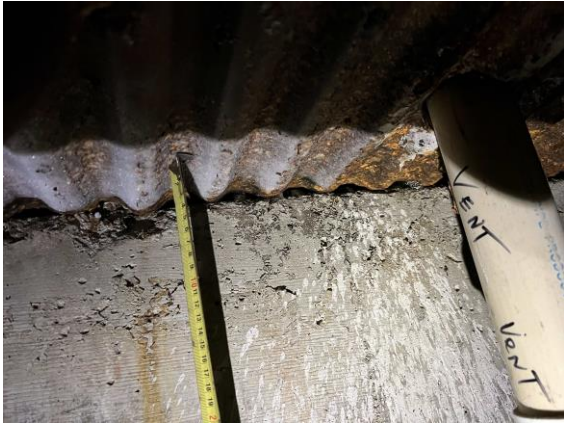
Although the concrete elements were in a serviceable state, the tunnel was notably cold and moist at the time of observation. This condition led to the formation of frost within the tunnel as shown in the photos at the end of this report. Presumably the atmospheric conditions that lead to this frost also contributed to the notable corrosion of the metal deck that was present on the roof of the tunnel.

Item S1 – Frost and deteriorating metal deck over utility tunnel located around perimeter of Main Level Classroom space.

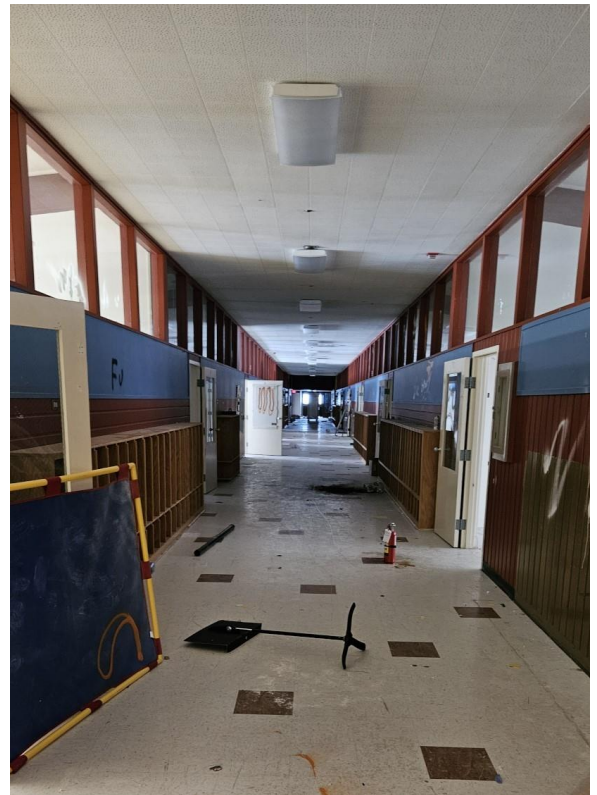
Item S3 – Main Level Classroom interior corridor, looking West. Note continuous windows in top reaches of walls.

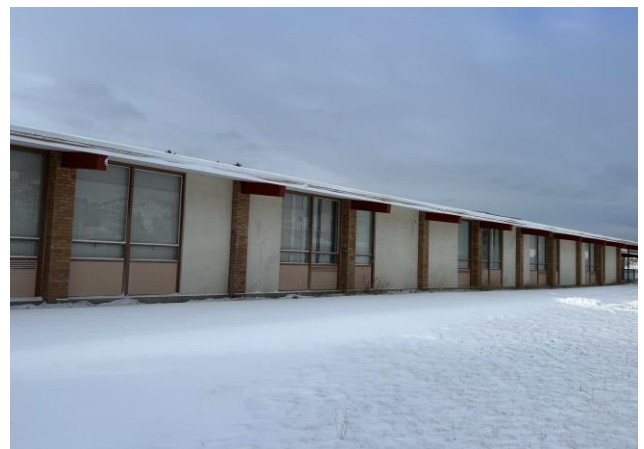
Item S3 – North exterior wall line of Main Level Classroom space. Full height walls present between window openings.

**Recommendation:** Despite the satisfactory condition of the walls observed in the original Main Level Classroom construction, current building design practice and building codes require framed walls that are part of the lateral force resisting system to be sheathed with an approved material, attached with approved fasteners at regular intervals. The site of the Dwyer School Building is classified as Seismic Design Category C and is therefore required to possess such walls, detailed for seismic resistance. By selectively infilling existing wall openings with properly sheathed framing and creating a continuous line of framing along the tops of these exterior walls, they could be brought up to current standards and used to provide effective, code compliant lateral load resistance in the East / West direction.

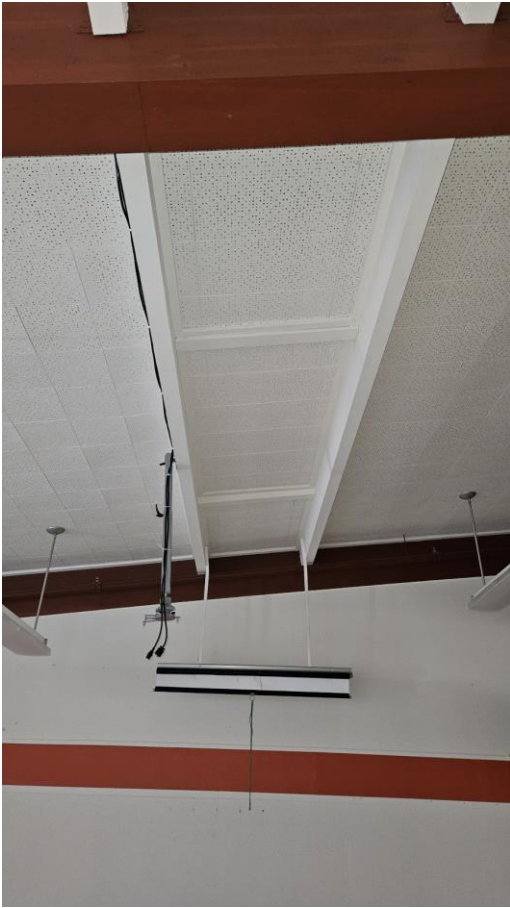
**Condition:** Where visible, the roof decking and framing did not show significant signs of degradation or structural distress. Beams witnessed were free of splits, large checks, and water damage within the building envelope. Where cantilevered glulam ends extended outside the building, they were painted with a thick

Preliminary calculations were performed on the main glulam girders and show that these members could be around 30% overstressed and exceeding code mandated deflection limits when subjected to design dead loads of 15 psf (pounds per square foot) and snow loads of [35 psf]. Similar calculations were performed on the car decking above these glulams and found that it could be overstressed by as much as 15% under similar design loads.

Item S4 – Typical roof framing observed from within classroom space.

Based on the conditions observed and preliminary calculations performed, it appears that the roof framing system is able to support significant portions of the imposed loads. With this being the case, it is recommended that this framing be utilized to the greatest extent possible and reinforced with additional members or components as necessary to meet the final design intent. These reinforcements could include the addition of new girders (where required to cut down deck span) and reinforcement of existing girders with steel plate or other wood members strategically placed and connected thereto that increase load carrying capacity.

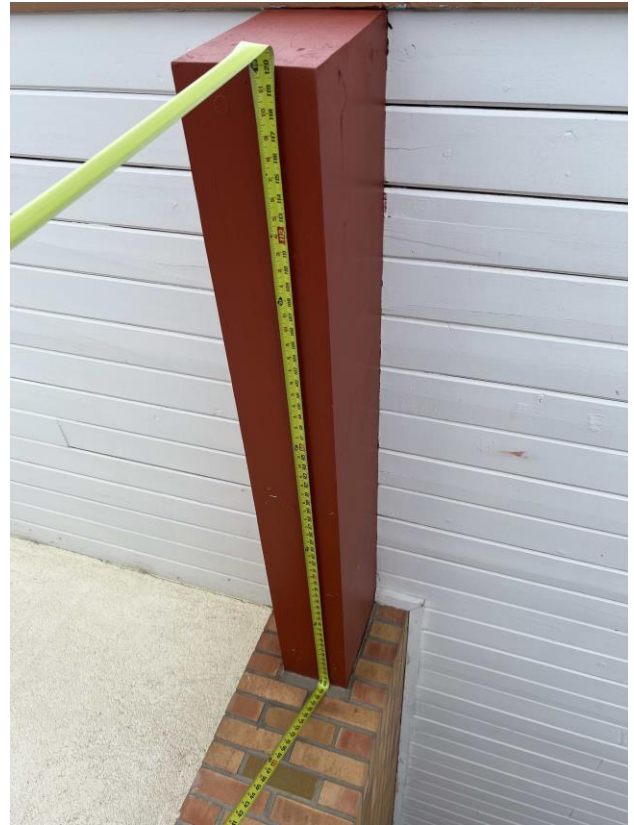
coating that appeared to be effective in shielding them from damage incurred by the elements, but some minor water damage was present on the beam ends extruding from the building.

Item S4 – Typical roof framing cantilever outside Main Level Classroom space.

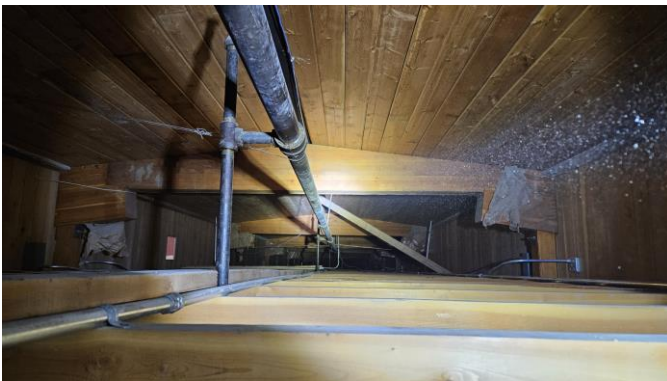
Item S4 – Typical Roof Framing over Main Level Classroom Hall 113.

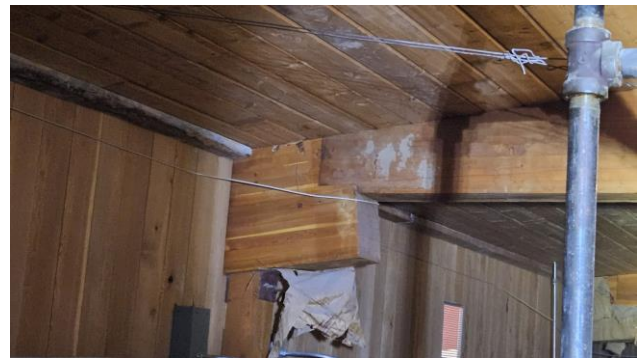
Item S4 – Classroom roof beam support and hallway beam connection at edge of Hall 113.

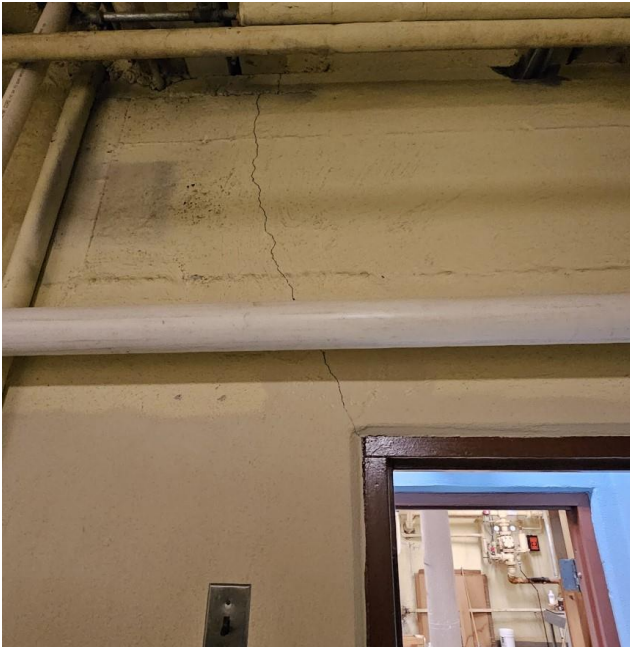
**Condition:** Where foundation walls were continuous from floor to ceiling (in the basement area), these walls appeared to be in good condition with a few sporadic cracks that were of little concern. Where openings were present in the foundation wall systems (at mechanical penetrations and door openings) cracks were often seen running at 45 degrees from the corners of wall openings or in vertical orientations, up the height of the wall. Cracks in these orientations and locations are typically of less concern than cracks running horizontally along a wall that would indicate a flexural failure of the foundation wall as it works to resist lateral soil pressures from the outside.

Item S5 – Typical foundation wall crack at door opening.

**Recommendation:** Given the minimal reinforcing steel witnessed in the foundation walls below the Main Level Classrooms, it is possible that cracks witnessed are the result of inadequate shrinkage and temperature reinforcement in the basement foundation walls and are of minimal structural concern. However, without documentation on the existing reinforcement contained within the foundation walls, it will be difficult to determine with certainty if the cracks witnessed in the foundation walls are the result of structural deficiencies.

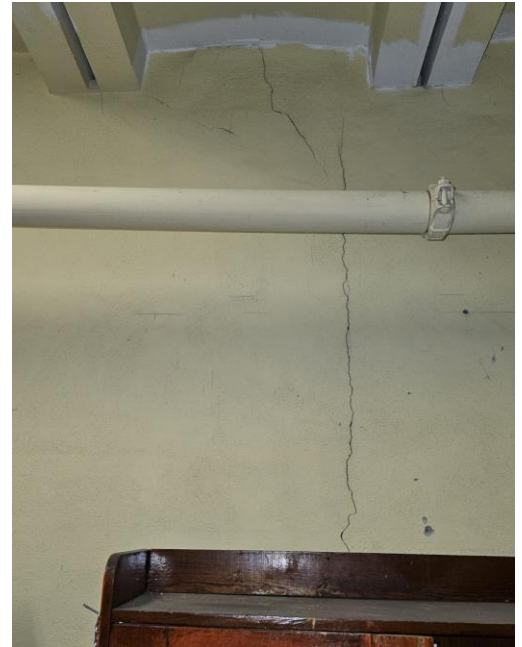
Item S5 – Typical foundation wall crack over cabinet in room 011

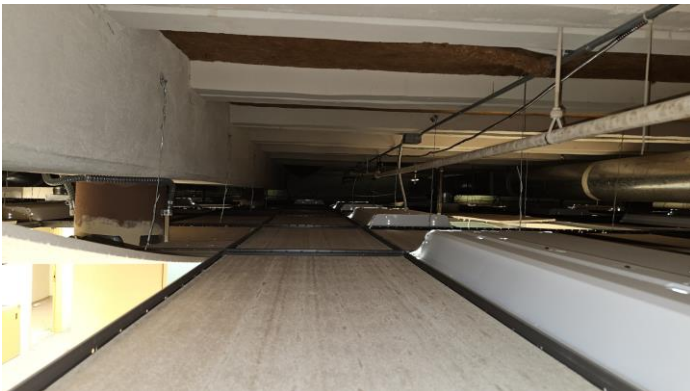
Item S6 – Typical gym floor construction above Room 003 at interior beam / column bearing line.

**Recommendation:** Although the structural floor systems observed appeared to be in sound condition, it is difficult to determine if the elevated (main level) floor system would be adequate to support design level loading of 100 psf (assembly-level live loads required for Recreation Center use). It is apparent that this reinforced concrete floor system contains reinforcing steel, but without existing design drawings the size, location, and grade of this reinforcement could not be determined at the time of observation. Without information on concrete strength and reinforcing steel, structural calculations to determine the load carrying capacity of these elements cannot be performed. The best source of information to aid in future calculations would be the existing drawings for this portion of the structure. If these drawings cannot be found, it is recommended that future efforts to determine the suitability of reuse include the development of a plan to obtain additional information on concrete strengths used in these systems and locations and size and grades of reinforcing steel by means of additional observations and possible localized destructive testing. See Item S5 discussions for additional information.

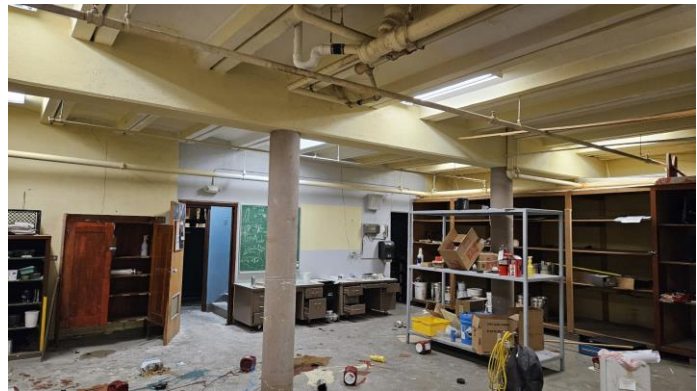
Item S6 – Typical floor construction above Room 011. Precast Longspan Channel Slab planks spanning to interior beam / column line.

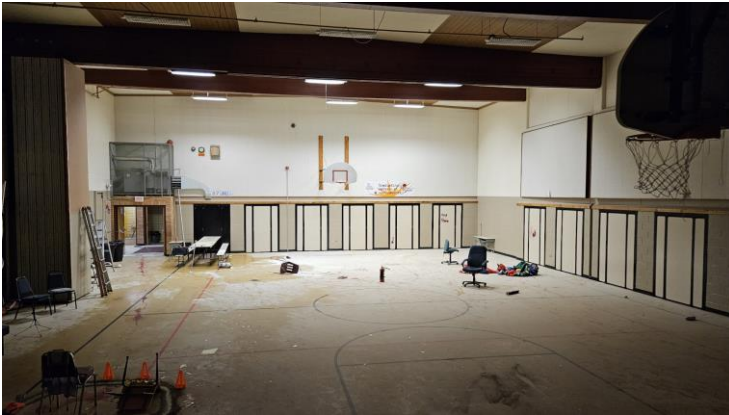
Item S7 – View of gymnasium, looking North from stage.

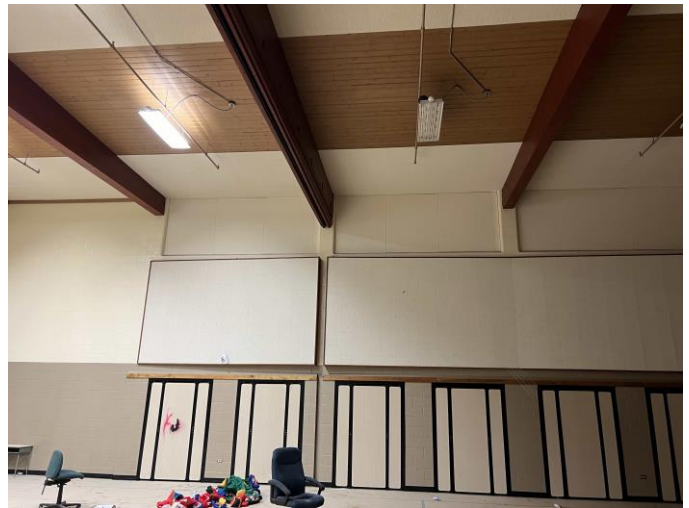
Item S7 – North half of East gym wall. Full height CMU wall section can be seen to left with partial-height infill shown (3) bays to the right.

Given the height (and weight) of the walls bounding the gym and the apparent lack of vertical reinforcement within, further structural analyses may require strengthening of the walls to resist out-of-plane seismic and wind forces and additional connection components to attach the tops of these walls to the roof diaphragm

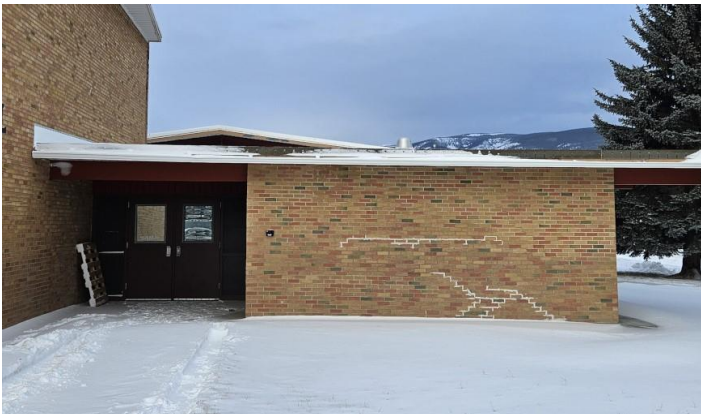
The exterior walls around Room 122 showed signs of potential settlement. Issues observed include cracking and subsequent repair of veneer mortar joints on the room's East wall. On the room's North wall, a gap of varying thickness is present between the top of the veneer and the roof decking above, indicating possible differential foundation settlement.

Item S7 – East Wall of Room 122. Damaged and subsequently repaired mortar joints can be seen.

Given the presence of differential settlements observed around the exterior walls of Room 122, it is possible that foundations beneath these walls are inadequate to resist the loads imparted. Future renovations of this building should investigate the need for foundation reinforcement below this portion of the building. These strengthening efforts may include the addition of helical piers, as discussed in item S1.

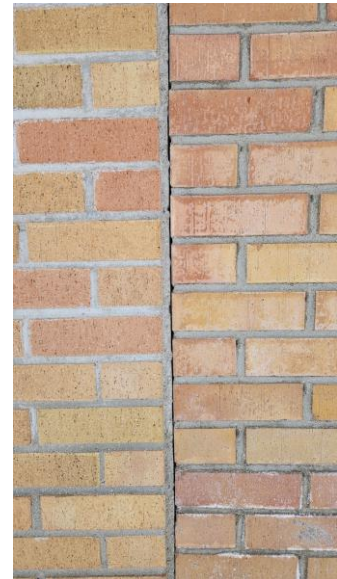
Item S7 – Masonry joint on north wall of Room 122. Variation in brick and differential movement can be seen between left wall (Room 122) and right wall (Stair 121).

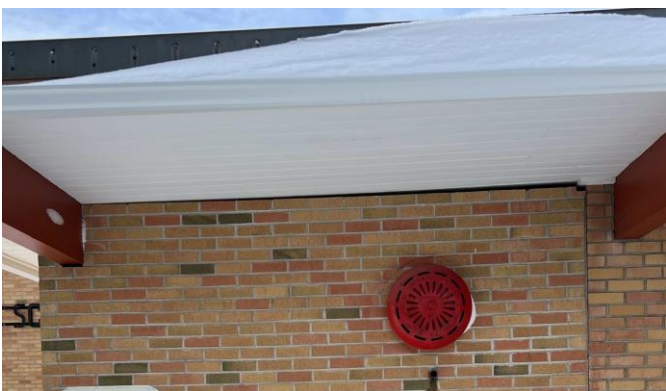
Item S7 – Top of Room 122 North wall. Gap between top of wall and roof deck varies in depth.

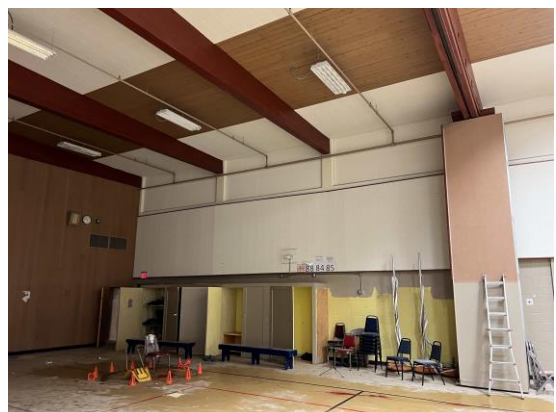
**Condition:** The condition of the gym roof framing and ceilings observed appeared to be satisfactory. No other cracking or serviceability issues appeared to be present in the remainder of this portion of building at the time of our visit to the site. Despite the lack of visual distress in the roof framing system, preliminary calculations show that roof framing elements (deck and glulam girders) could be overstressed by as much as 10% under design level loading.

Item S8 – Typical gym roof framing. Car decking spanning between tapered glulam girders that reside on CMU pilasters.

**Recommendation:** Given the observed overstress in roof framing shown preliminary calculations, it is possible that existing roof framing will require strengthening efforts to resist the design level loading mandated by current codes. This strengthening could come in the form of the addition of supplementary framing members and / or the addition of steel plates or additional wood sections to be added to the existing members.

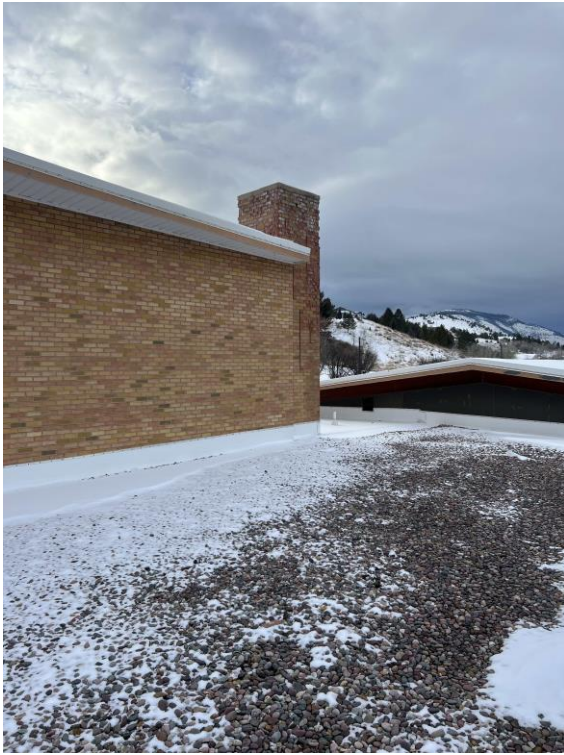
Similar to the gym roof, lower roofs (to the North and West of the gym) did not show visual signs of structural distress in the areas observed. However, given the likelihood of drifts collecting on these lower roofs and observation of other roof member overstress in preliminary calculations, it is probable that roof framing members in these sections of the building would be overstressed when subject to design level loading.

Item S8 – Ballasted lower roof, North of upper gym roof.

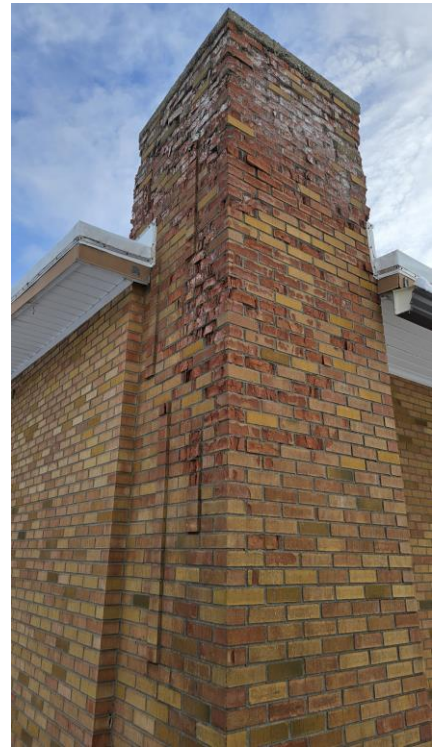
**Condition:** In the lower reaches of the chimney, the existing brick appears to be in sound condition. However, higher up on the chimney the brick appears to be deteriorating, with portions spalling away and efflorescence present above the upper gym roof level. The presence of reinforcing steel within the masonry was not verified at the time of observation.

Item S9 – Deteriorating brick chimney at Northwest corner of gym roof.

**Recommendation:** In Hicks Engineering’s experience, masonry chimneys constructed in this era are often unreinforced and present a risk of collapse in seismic event. It is recommended that future design efforts aim to remove this chimney from the structure or provide sufficient strengthening to sufficiently adhere the chimney to the structure to preclude the danger of collapse onto lower levels in a seismic or wind event.
