## **W.K. DWYER SCHOOL BUILDING** **STRUCTURAL SYSTEM EVALUATION**

The W.K. Dwyer School Building is located on the West side of Anaconda, MT at 1601 Tammany St. The school served the community of Anaconda from completion of construction in the late 1950's to the mid 2010's when School Board budget constraints necessitated its closure. With the school currently vacant, a desire to transform the building into a community center has arisen. In support of this desire, Hicks Engineering has been hired to provide documentation of structural systems present, a conditional assessment of those systems, and any foreseeable modifications to these systems required to transform the building into a safe and serviceable community center.

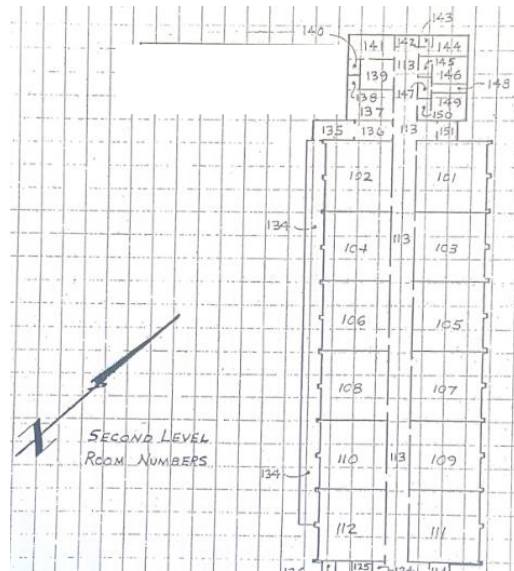
Figure 1- Main Level Classrooms (shown not to scale)

**Description:** The exterior foundations, below the Main Level Classrooms, were accessed from within a lower-level utility tunnel that runs the perimeter of the West section of the building (labeled Room 012 in Appendix A). From within this tunnel, it could be seen that the exterior foundations consist of 10"-thick concrete foundation walls with #3 bars @ 12" o.c. (on center) each way, centered in the wall. Foundation walls do not appear to have continuous footings beneath and were constructed as 10" wide x +/- 4'-6" tall continuous grade beams.

Small spread footings could be seen protruding beyond the wall's base at masonry pilaster locations (above). Their width was measured as 28" (parallel to the wall), but given the one-sided access to the foundation wall, their overall dimensions could not be measured. Also coming off the bottom of the foundation walls were 12" wide grade beams that spanned the base of the utility tunnel, located between each pilaster footing location. These grade beams were spaced at roughly 15'-0" o.c. along the length of the tunnel and presumed to be bracing the bottom edges of the tunnel's interior and exterior walls from sliding inward due to lateral earth pressure. Capping the tunnel and bracing the top of the walls was a +/- 6 1/2" thick concrete slab on non-composite metal deck.

**Condition:** Given their age, the exterior concrete foundation elements observed (walls, footings, and perpendicular grade beams) appeared to be in sound condition. The elements observed did not show signs of significant structural cracking, spalling, or other degradation that would indicate a loss in structural load-carrying capabilities. Despite the elements being in good condition, it is likely that due of the lack of a significant footing system below the foundations walls, the foundation system will produce excessive bearing pressures on the sub grade below relative to acceptable soil bearing capacity if analyzed under current building code requirements.

Although the concrete elements were in a serviceable state, the tunnel was notably cold and moist at the time of observation. This condition led to the formation of frost within the tunnel as shown in the photos at the end of this report. Presumably the atmospheric conditions that lead to this frost also contributed to the notable corrosion of the metal deck that was present on the roof of the tunnel.

**Recommendations:** When considering the repurposing of this structure, the design team should understand that the existing exterior foundations will likely require additional support. Post-installed helical piers with retrofit connections to the foundation walls / grade beams would be a minimally intrusive option when deployed at targeted discrete points around the exterior foundations. It is also recommended that the design team develop a plan to provide improved insulation and damp proofing to utility tunnel that wraps the building perimeter.

In anticipation of structural foundation bearing capacity issues at interior structural support lines, the design team should be prepared to indicate drilled and epoxy anchorage and cast in place concrete footing extensions to existing interior footings where necessary to support post load and bearing / shear wall reactions where present.

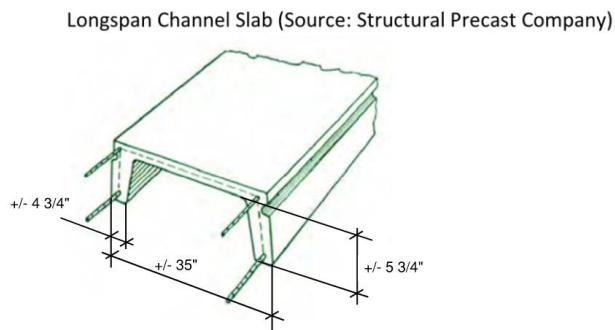
**Figure 4 – Longspan Channel Slab Plank Figure**

**Description:** The structural floor system at the lower level (basement) of the building consists of a concrete slab-on-grade. The floor system for the upper level (at grade) consists of presumably precast concrete “Longspan Channel Slab” planks spanning between lines of +/- approximately 18”-wide x 14” deep either pre-cast or cast-in-place concrete beams supported on +/- 12” diameter concrete columns. It is anticipated that a concrete topping slab was poured over the top of the precast planks, due to the presence of concrete seepage in the joints between planks. However, the thickness of this topping was not determined as part of these observations.

Above basement Room 003, the aforementioned concrete planks span East / West from exterior foundation walls to two interior concrete beam / column lines that are each located +/- 17'-4” from exterior foundation walls with a +/- 17'-4” spacing between these two beam / column lines. This creates three plank-spans across the floor of the gym. A figure, depicting this framing system, can be found in Appendix C and a representation of the concrete planks can be found in the figure below.
